22
1st Part of Report
No. AAEE/866/5

SHACKLETON MK. 2 PHASE 3

NAVIGATION AND RADIO C.A. RELEASE TRIALS

**SQN. LDR. D. A. STONEHOUSE, R.C.A.F. AND FLT. LT. R. E. GRIFFITHS, B.Sc.(Eng.)
NAVIGATION AND RADIO DIVISION**

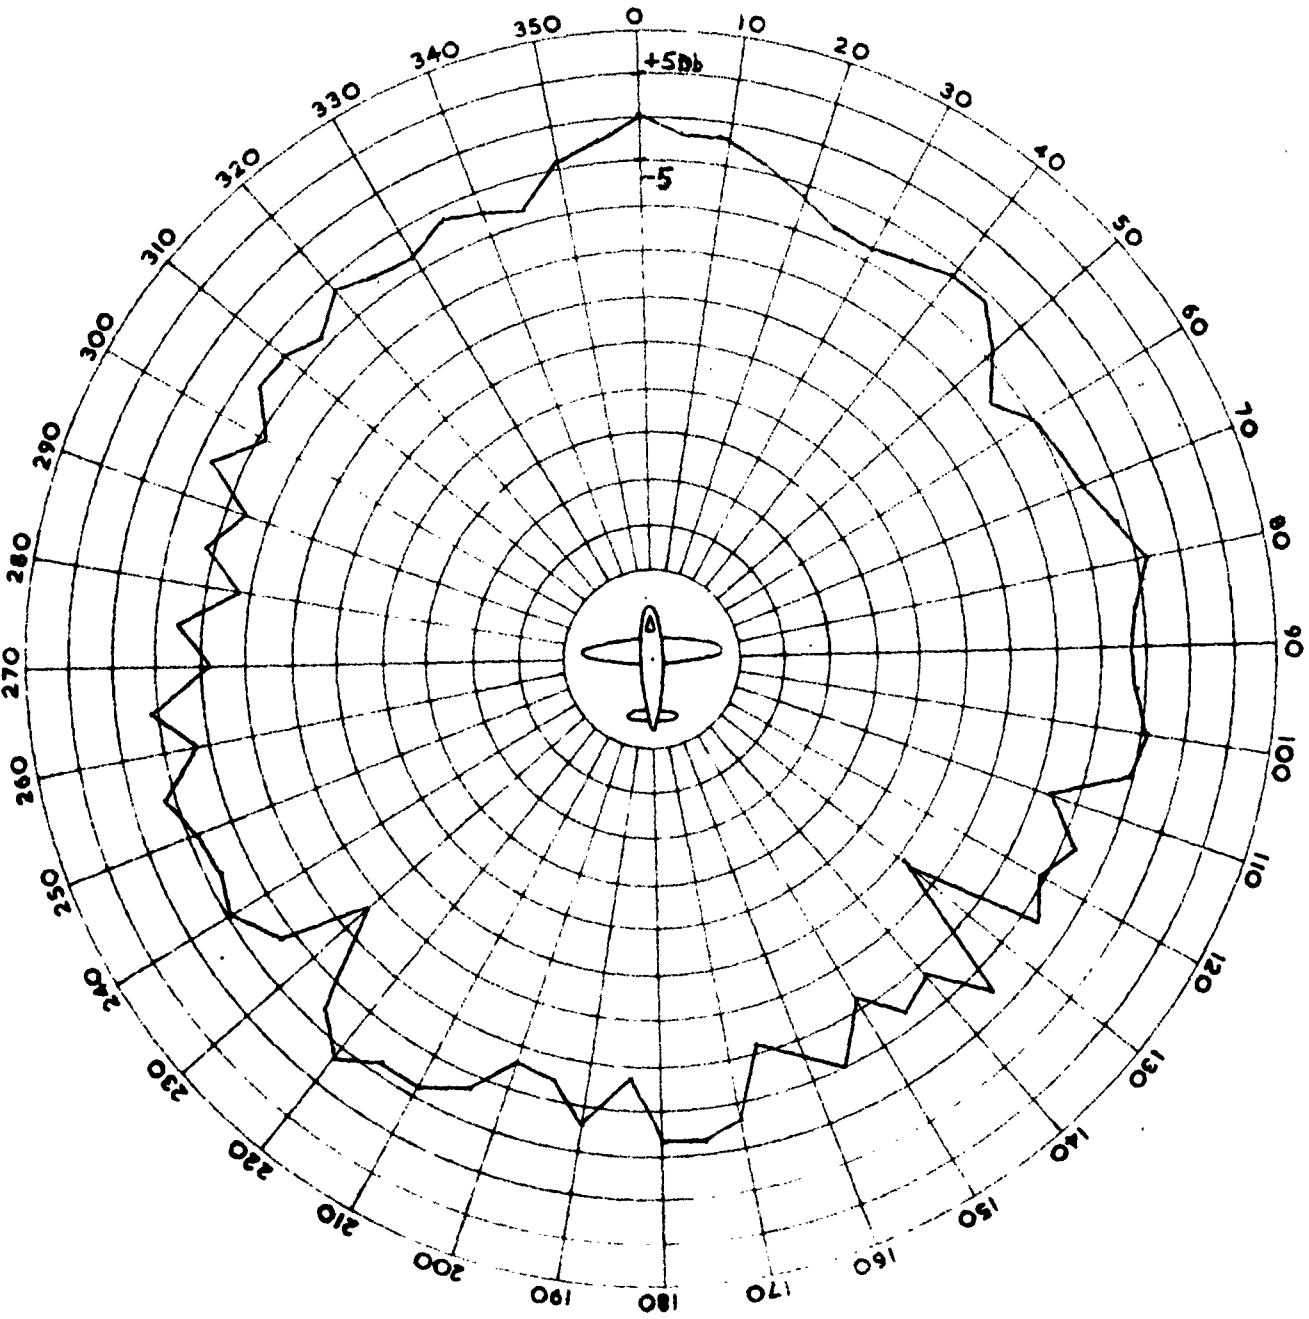
Fig. 2.

The installation is physically adequate but the aerial radiation patterns (see Figures 2 - 6) are outside the specification, RAE/XRSP 3247, in that there is an 11 dB drop in signal strength over 10 degree sectors at 150 degrees and 170 degrees relative. However range checks in this area of doubt were carried out and near maximum possible line of sight ranges were achieved. The EAM 35 amplifier in the M22 interconnecting box was adjusted so that its output power was 200 mW. This proved to be a satisfactory level as in the Mark 3 Phase 3 trials. (See 1st Part of Report AAEE/866/4 Appendix IV). C.A. release is recommended for the V.H.F. AD 160.

SHACKLETON MR2 - WG 556
V.H.F. AERIAL
AZIMUTH RADIATION PATTERN
GROUND MEASUREMENT

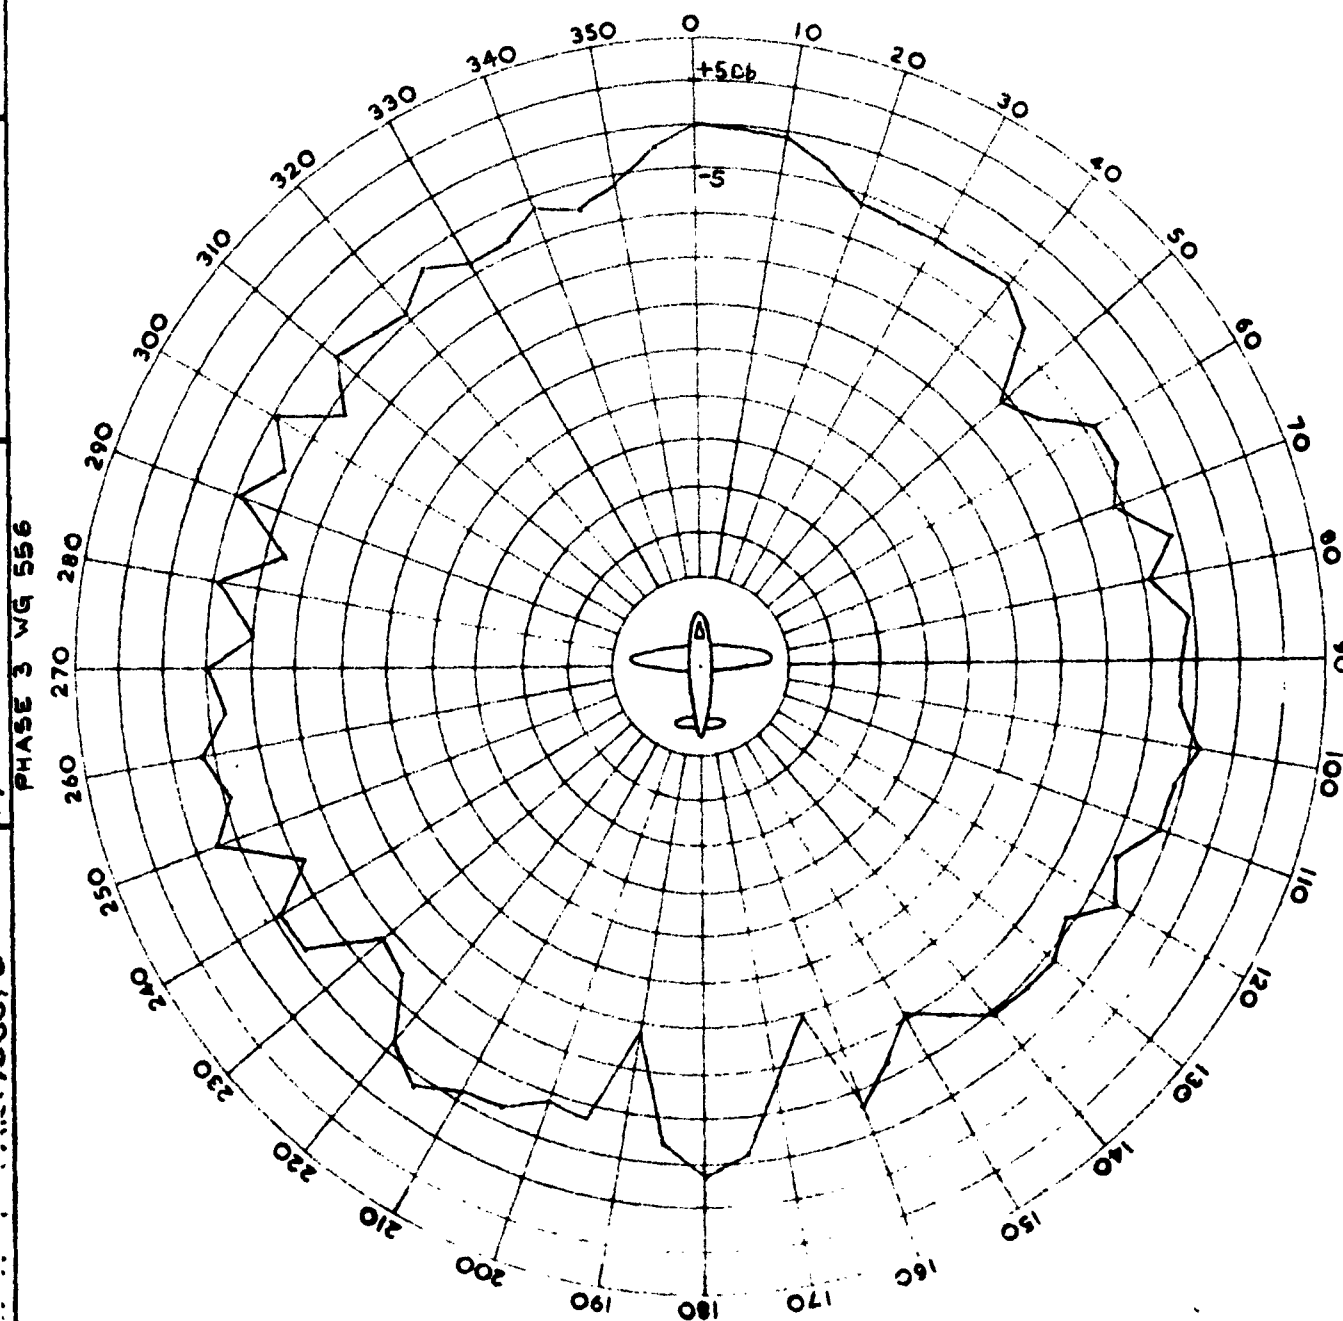
SHACKLETON MR2 - NG556
V.H.F. AERIAL
AZIMUTH RADIATION PATTERN
GROUND MEASUREMENT

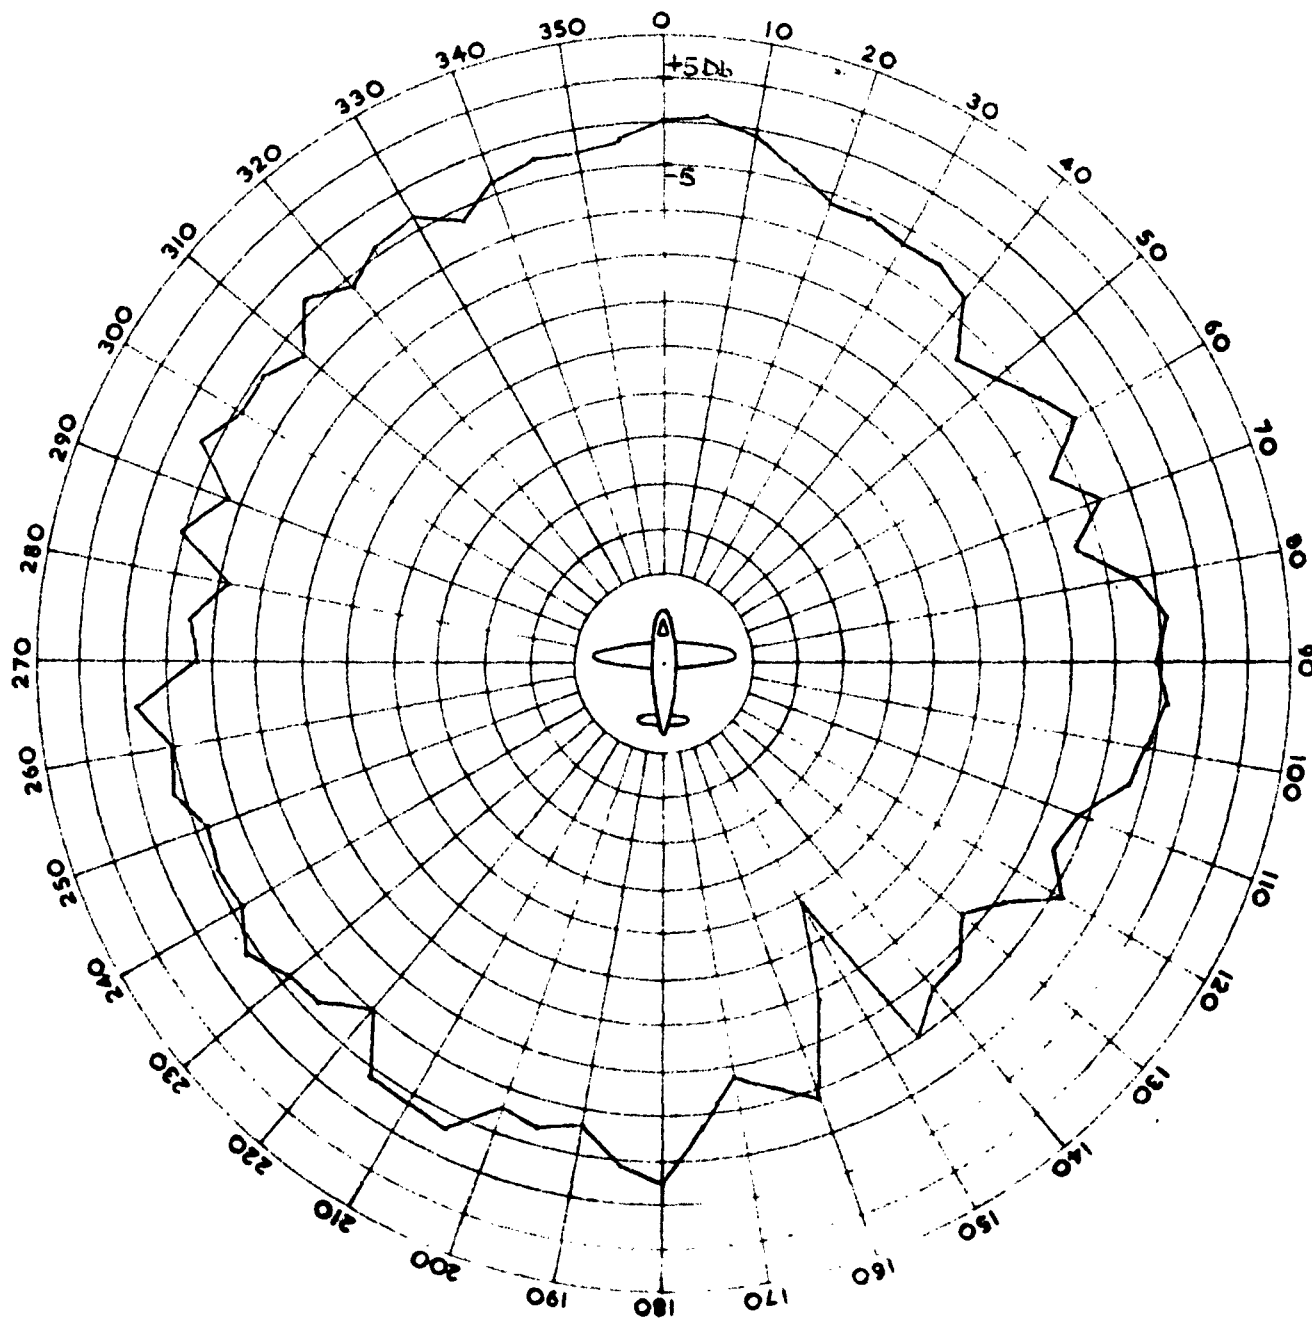
FIG 4

SHACKLETON MR2 - WG 556

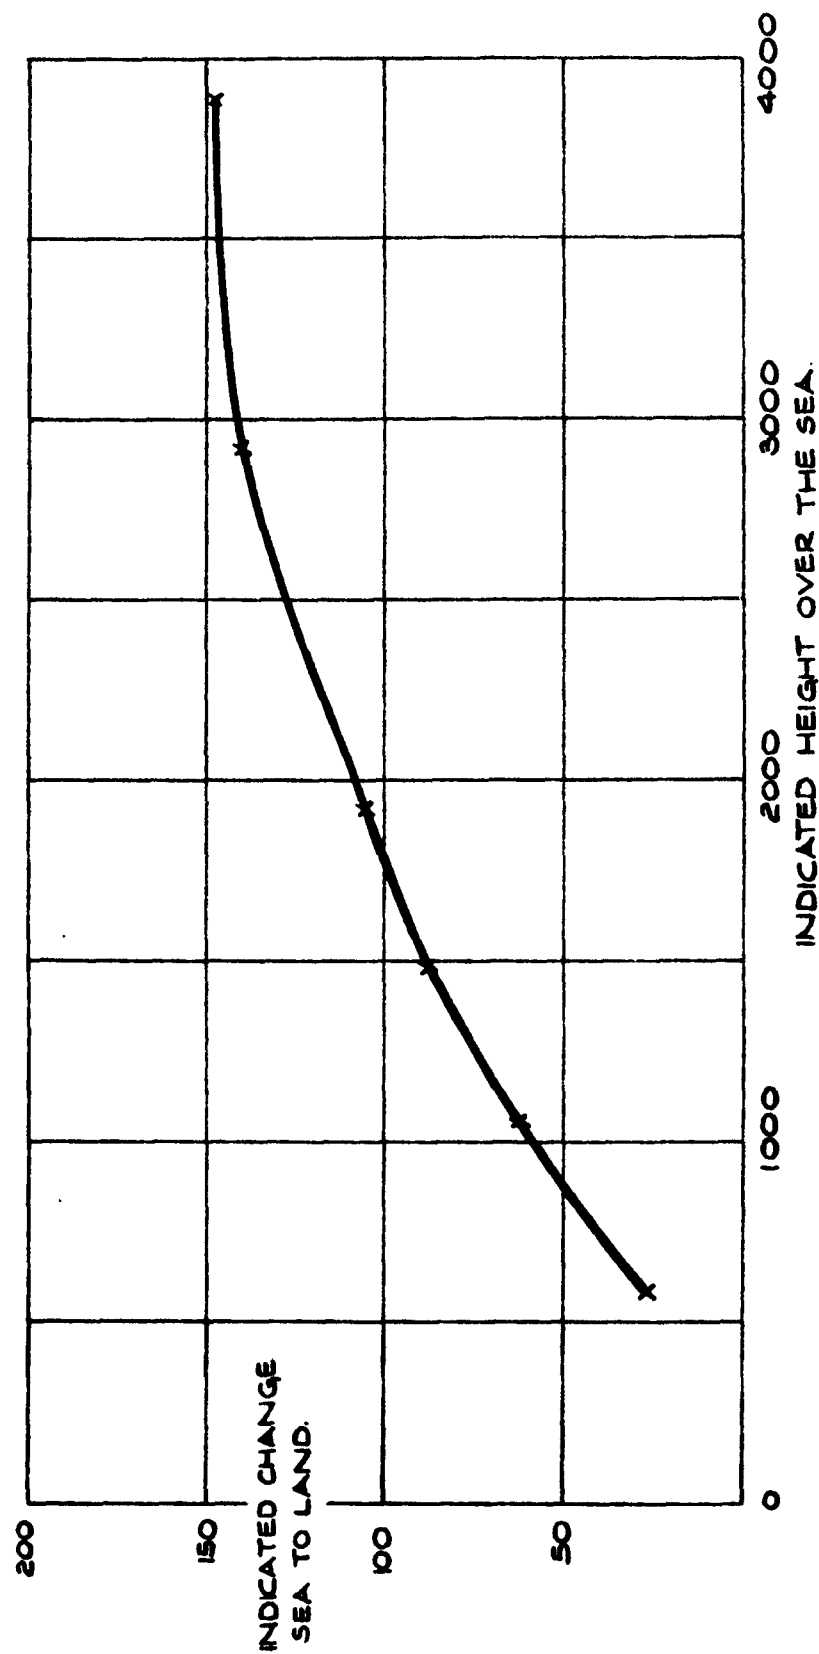
FIG. 12.

The accuracy of the equipment was ascertained by calibration runs against the kinetheodolites at R.A.E. Aberporth and by sea-to-land runs near Burnham-on-Sea. The results of the Aberporth trials in the height bracket 100-5,000 feet are shown in Figure 11 and the sea-to-land results are in Figure 12. From the results the overall accuracy over land and sea is within the limits $\pm 3\%$ of height ± 5 feet.

RADIO ALTIMETER CALIBRATION SEA TO LAND CHANGE.
